## **PERU LNG**

### **Independent Environmental and Social Monitoring – IESM March 01 to 03 /2010 Monitoring Mission**

### **Pipeline Final Report**

March 2010

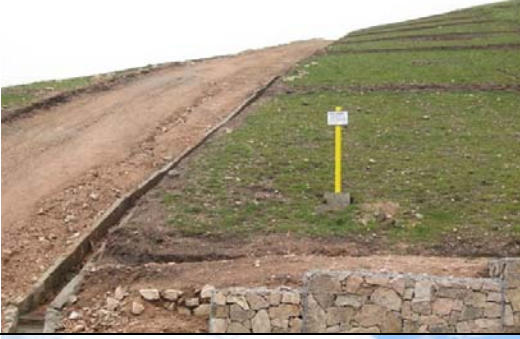
| | <p><b>Local:</b> Crossing Kp 077 and Valve # 3</p> <p><b>Comment:</b> As most of crossings with public roads in court incline were built gabions to stabilize the RoW. Road access to the valve, which is permanent, includes a water made with cement drainage channel and the channel by its slope has energy sink</p> |

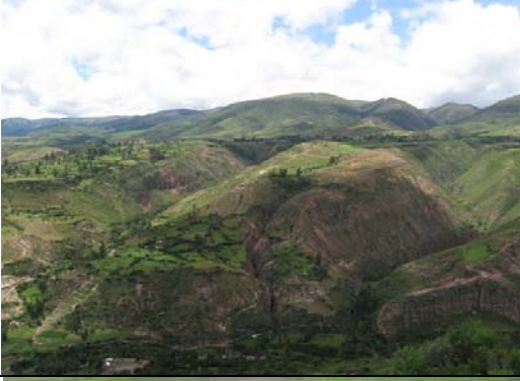
| | <p><b>Local:</b> Huaychao camp area</p> <p><b>Comment:</b> Panoramic view of the area where the Huaychao) camp was located (mountain plateau. The Row can hardly see on the slope of the Yucay River on its right bank</p> |

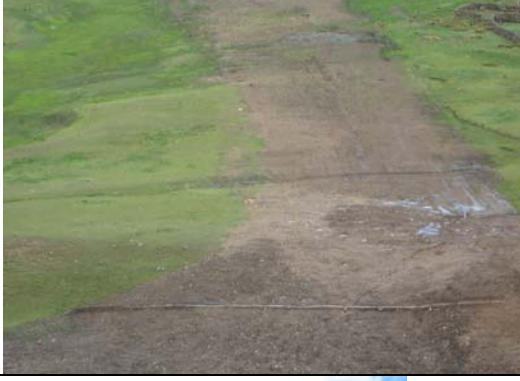
| | <p><b>Local:</b> River Palmitos crossing</p> <p><b>Comment:</b> Note the erosion control works. This crossing did not use seed</p> |

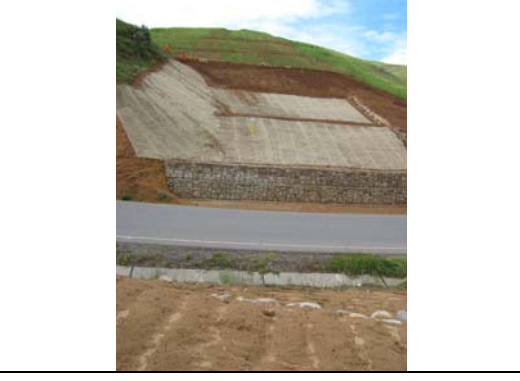
| | <p><b>Local:</b> The Libertadores route crossing</p> <p><b>Comment:</b> Note the planting of naturalized pastures and coverage of jute erosion control works</p> |

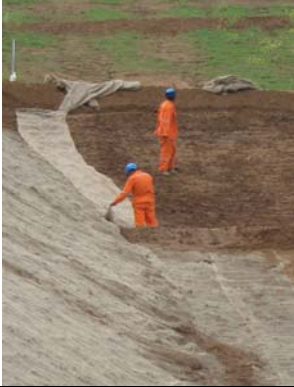
| | <p><b>Local:</b> The Libertadores route crossing</p> |

| | <p><b>Comment:</b> Work placement of jute on sowing naturalized grasses</p> |

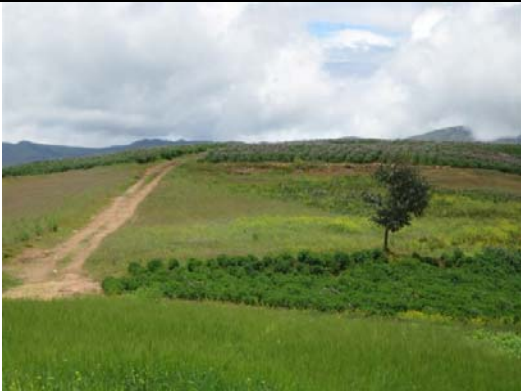
| | <p><b>Local:</b> Acrocco camp area</p> |

No erosion control problems were observed at the decommissioned campsite areas that were inspected (Accocro, Campana, Chaquicocha). Decommissioning procedures were considered complete and included reinstatement of the sites to their original topography and bio restoration, as well as implementation of slope breakers or other geotechnical erosion control measures as applicable. Soil investigations to confirm absence of contamination in key areas was reported to be complete, with no negative results (i.e. no evidence of contamination). In the specific case of Accocro, much of the camp's area was being farmed.

| | <p><b>Comment:</b> Acrocco camp was decommissioned and returned to their owners through signed records. The ground is completely revegetated and part of it is already crops with owners' crops. Note the middle road used by the owners and that crosses the ground of ex camp</p> |

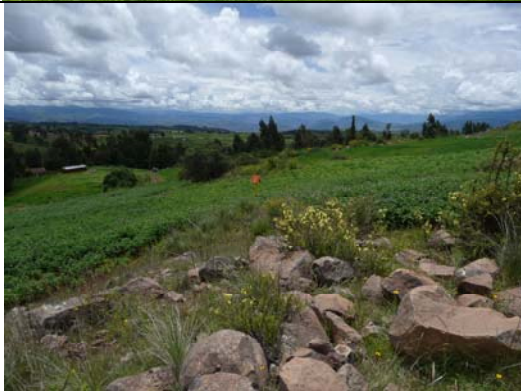
| | <p><b>Local:</b> Acrocco camp area</p> |

| | <p><b>Comment:</b> In Acrocco camp area, the ground is completely revegetated and part of it is already crops with owners crops</p> |

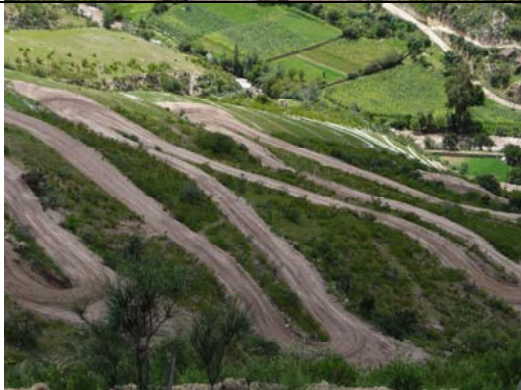
| | <p><b>Local:</b> Yucay River crossing</p> |

At some points where the RoW is intercepted by roads, runoff from the road surface is flowing over the RoW and is affecting areas that have been biorestore. In some cases it is flowing along the RoW's slope breakers and sediment deposition is leading to overflowing. Though problems observed were minor, the risk for more significant impacts exists and in all cases observed the applicable corrective measures are simple.

| | <p><b>Comment:</b> Access road (shoofly) unpaved. Sediment runoff from the roads' surface was seen to enter sectors of the RoW that had already been reinstated and where biorestitution has been initially implemented, locally affecting its success</p> |

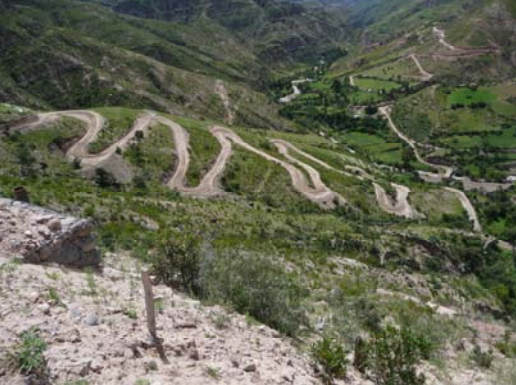
On the steep slope going down to the Yucay River crossing, the access road that zig-zags down besides the alignment had been recovered. Though this is a public road, it had its alignment slightly modified during construction and was upgraded. No adequate drainage was in place and erosion has occurred where rainfall is allowed to flow away from the road's surface in the direction of the slope's natural drainage channels. Similarly, part of the road's surface is drained towards slope breakers in the pipeline's RoW, and this flow of rainfall could cause some erosion problems (or at least risks) on the downstream end of the breakers.

| | <p><b>Local:</b> Slope approaching the Yucay River crossing</p> <p><b>Comment:</b> Local unpaved road that zigzags its way up the slope with general alignment parallel to the RoW, and that was mostly reconstructed by the Project, was found to need significant drainage improvements</p> |

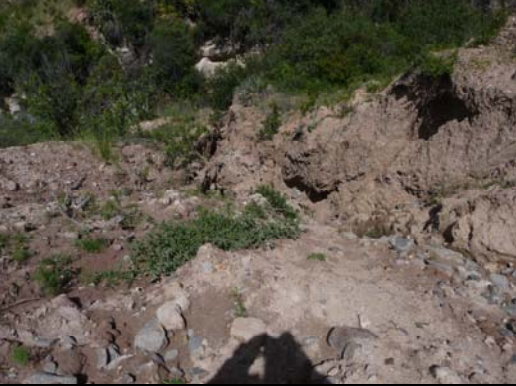
| | <p><b>Local:</b> Slope approaching the Yucay River crossing</p> <p><b>Comment:</b> Erosion point near the road. Due to additional flow received from the road, it is necessary to implement some hydraulic dissipaters on the downstream end of the RoW</p> |

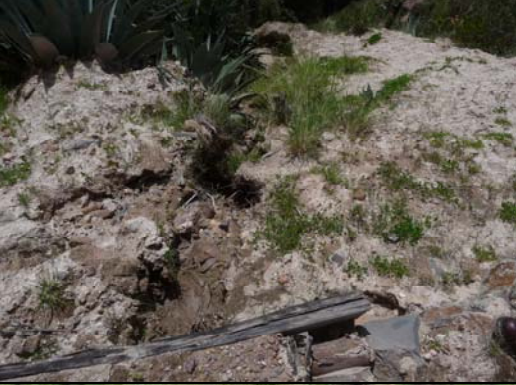
| | <p><b>Local:</b> Slope approaching the Yucay River crossing</p> <p><b>Comment:</b> At the curves of the zigzagging alignment, water from this channel should be directed towards an appropriate hydraulic structure that will release it to the adjacent natural channels, avoiding any local erosion</p> |

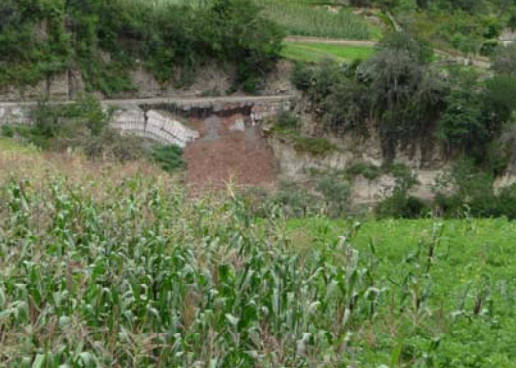
| | <p><b>Local:</b> Yucay River crossing</p> <p><b>Comment:</b> The ground has been reestablish and delivered to the owners. The land is clean and stable without signs of erosive processes</p> |

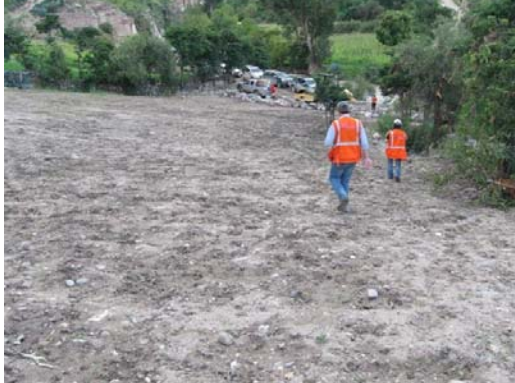
| | <p><b>Local:</b> Yucay River crossing</p> <p><b>Comment:</b> Ground where the camp was located for the crossing of the Yucay River and hydrostatic testing. The ground has been reestablish and delivered to the owners. The land is clean and stable without signs of erosive processes</p> |

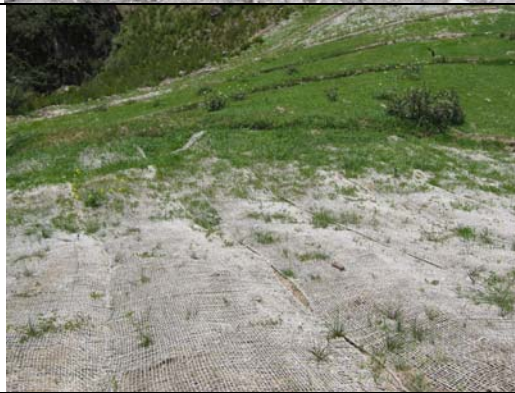
| | <p><b>Local:</b> Yucay River crossing</p> <p><b>Comment:</b> Hydro-seeding and jute application erosion control works</p> |

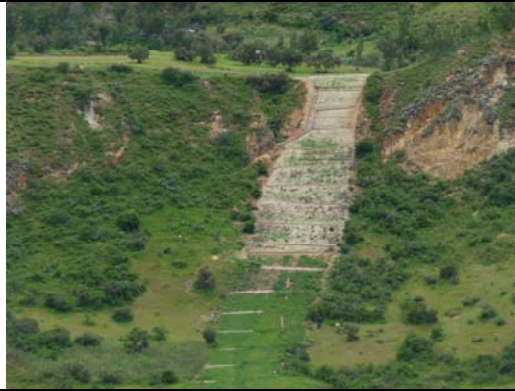
| | <p><b>Local:</b> Yucay River crossing</p> <p><b>Comment:</b> Work results of sowing for erosion control</p> |

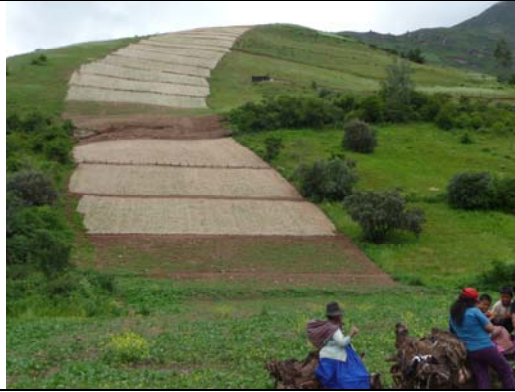
| | <p><b>Local:</b> Campana camp region (Kp 026)</p> <p><b>Comment:</b> Work results of sowing for erosion control</p> |

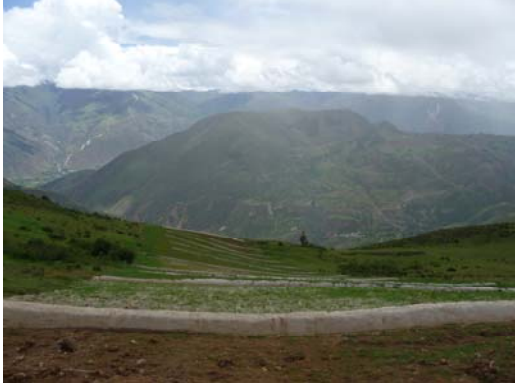
| | <p><b>Local:</b> Campana camp region</p> <p><b>Comment:</b> Work results of sowing for erosion control</p> |

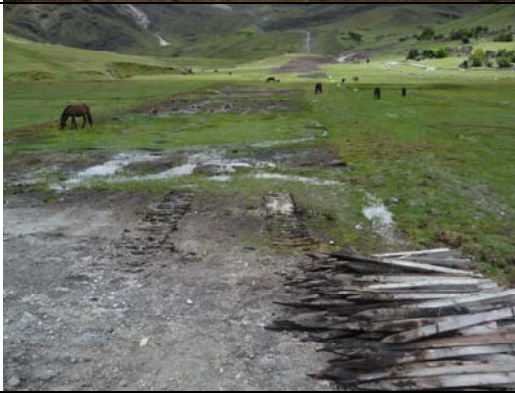
| | <p><b>Local:</b> Campana camp region (Kp 021)</p> <p><b>Comment:</b> Bofedal area with works for soil recuperation</p> |

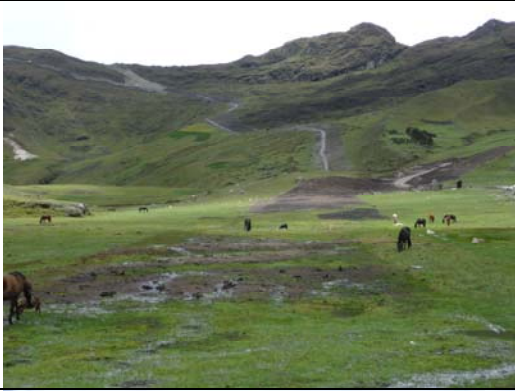
| | <p><b>Local:</b> Campana camp region (Kp 021)</p> <p><b>Comment:</b> Bofedal restoration</p> |

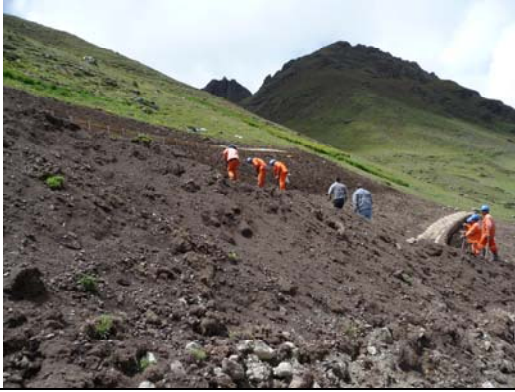
| | <p><b>Local:</b> Campana camp region (Kp 024)</p> <p><b>Comment:</b> Work seeding in the slopes</p> |

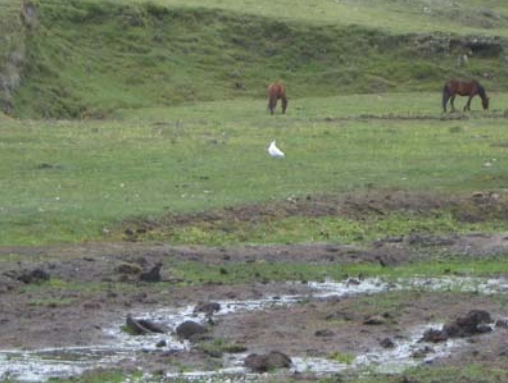
| | <p><b>Local:</b> Campana camp region (Kp 021)</p> <p><b>Comment:</b> Bofedal recovery work</p> |

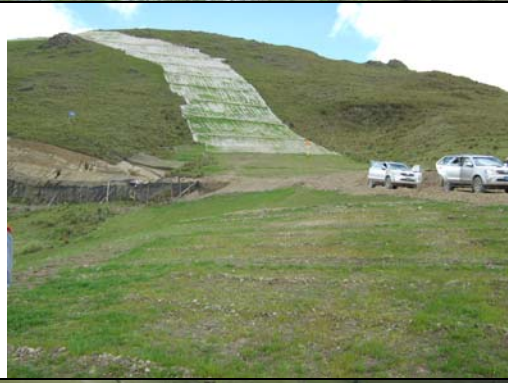
| | <p><b>Local:</b> Campana camp region (Kp 026)</p> <p><b>Comment:</b> Work Results of sowing for erosion control</p> |

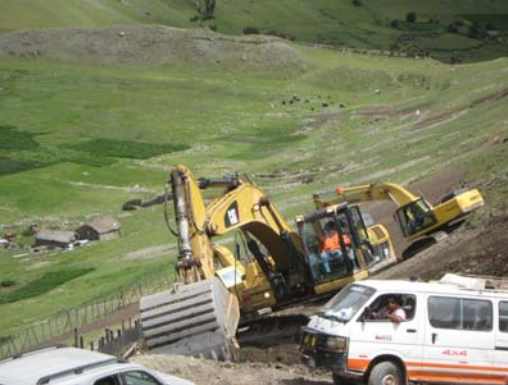
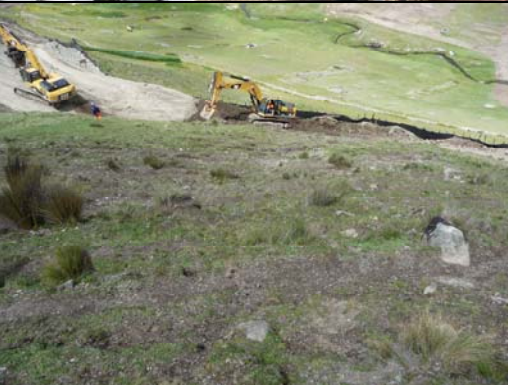
| | <p><b>Local:</b> Campana camp region (Kp 031)</p> <p><b>Comment:</b> Geotechnical recomposition works</p> |

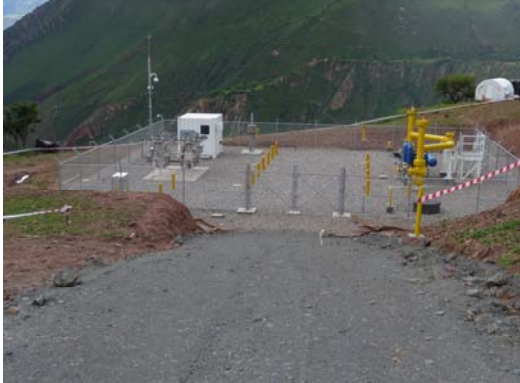
| | <p><b>Local:</b> Valve # 1 (Pampas River region)</p> <p><b>Comment:</b> The need for complementary drainage works to ensure that no erosion will affect this area, in the future, was observed on site</p> |

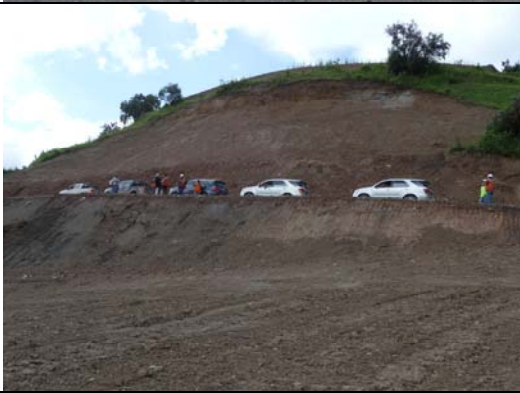
| | <p><b>Local:</b> Pampas River crossing (Kp 190)</p> <p><b>Comment:</b> Geotechnical recomposition works</p> |

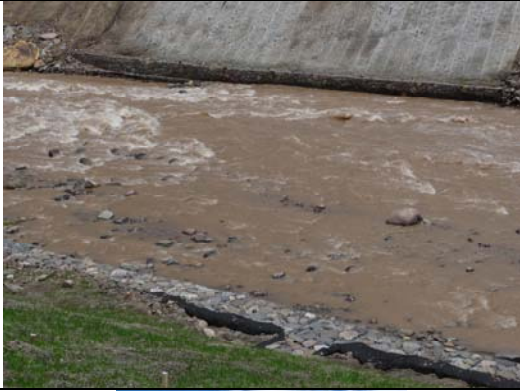
| | <p><b>Local:</b> River Pampas crossing (Kp 190)</p> <p><b>Comment:</b> Gabions and work results of sowing and jute for erosion control</p> |

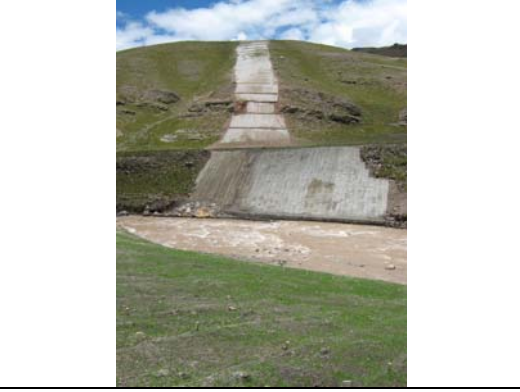
| | <p><b>Local:</b> River Pampas crossing (Kp 190)</p> <p><b>Comment:</b> Activities surrounding the Pampas River crossing. Note the proper use of jute and work for the erosion control</p> |
