**PERU LNG**  
**Independent Environmental and Social Monitoring – IESM**  
**July 10-11 / 2009 Monitoring Mission**

**LNG Plant and Marine Facilities - Final Report**

August, 2009

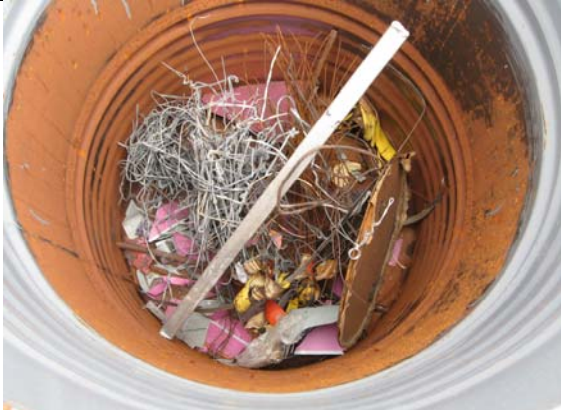
| | <p><b>Site:</b> Construction front in the LNG Plant Utilities Sector</p> <p><b>Observations:</b> Scrap waste container with leftover food</p> |

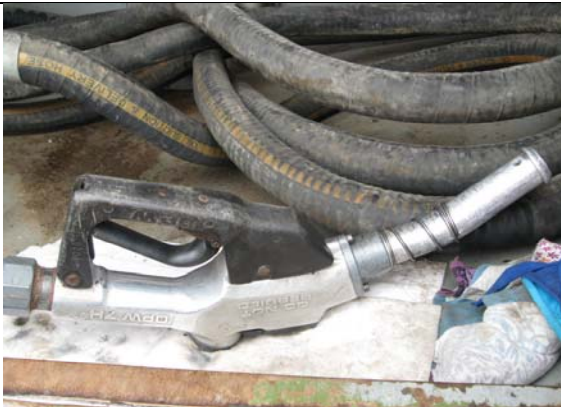
| | <p><b>Site:</b> Construction front in the LNG Plant Process Sector</p> <p><b>Observations:</b> Fuel supply tank not provided with grounding metallic connections or conductors to neutralize potential static charges before the transfer of liquid hydrocarbons between containers or during the transfers, in order to prevent ignition of vapors due to electrical static discharge</p> |

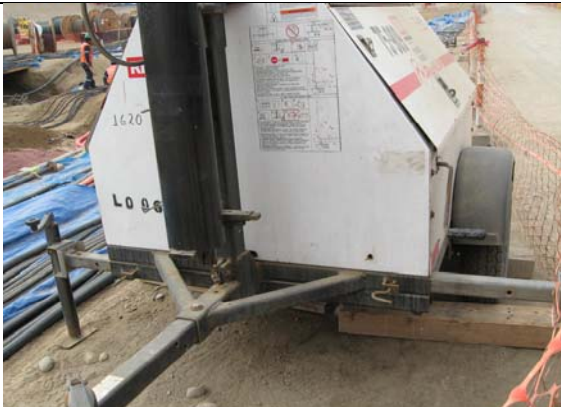
| | <p><b>Site:</b> LNG Plant Main Process Area</p> <p><b>Observations:</b> Mobile generator without spill tray to collect possible fuel or lubricant seepages</p> |

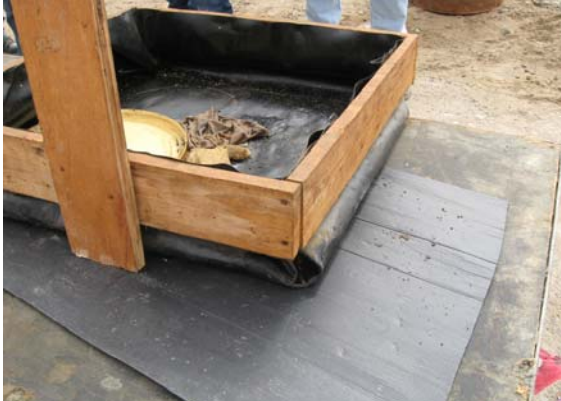
| | <p><b>Site:</b> LNG Plant construction front</p> <p><b>Observations:</b> Spill tray requiring maintenance due to lack of impermeability</p> |

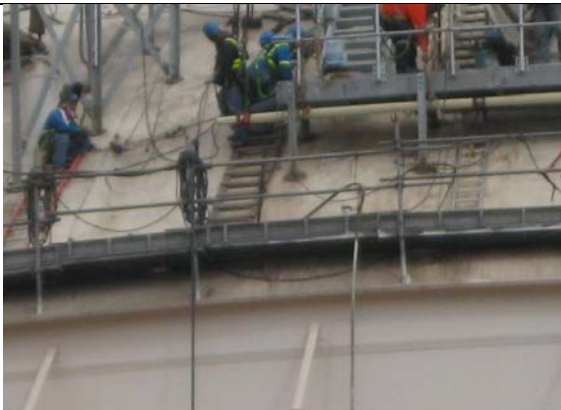
| | <p><b>Site:</b> LNG Tank</p> <p><b>Observations:</b> Workers with appropriate PPE for work at height</p> |

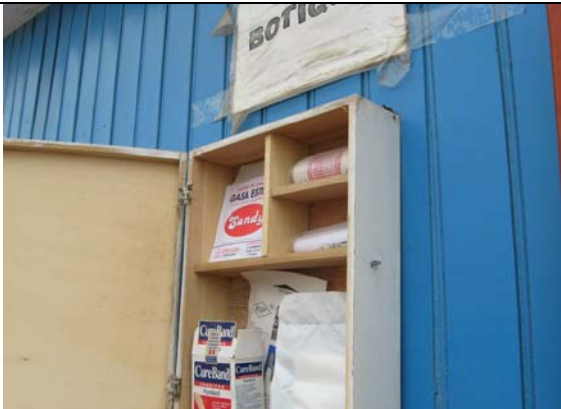
| | <p><b>Site:</b> COSAPI Camp</p> <p><b>Observations:</b> First Aid Kit without all required instruments and medicines</p> |

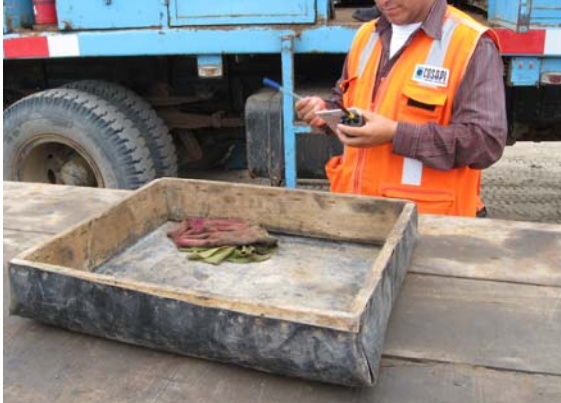
| | <p><b>Site:</b> COSAPI Camp</p> <p><b>Observations:</b> Perforated spill tray, belonging to lubricant supply truck, and which requires replacement or fixing</p> |

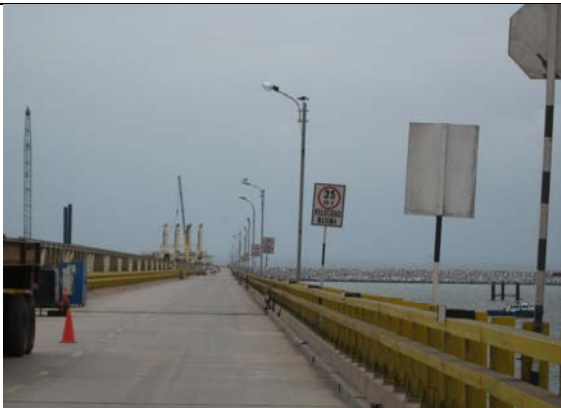
| | <p><b>Site:</b> Marine Terminal</p> <p><b>Observations:</b> Aproppiate Traffic Signage</p> |
