**PERU LNG**  
**INDEPENDENT ENVIRONMENTAL AND SOCIAL MONITORING – IESM**

**2012 ANNUAL MONITORING PROGRAM**

***PLANT AND PIPELINE REPORT***

**(MISSION APRIL 3<sup>rd</sup> to 12<sup>th</sup>, 2013)**

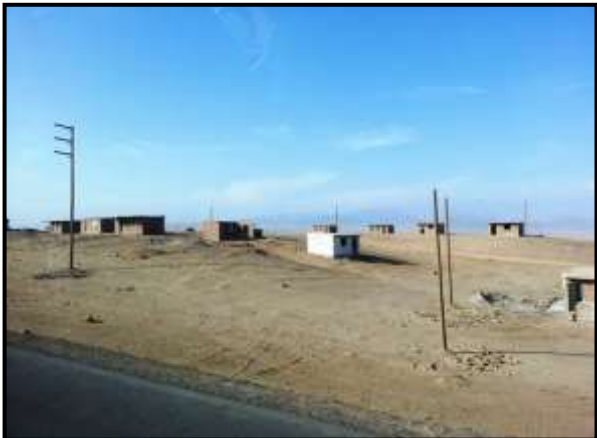
<p><b>Picture Nr. 1</b>            New settlement rapidly growing along the Panamericana (South) Road, nearby the Melchorita Plant. Although not formally recognized, the new settlements are undergoing a process of formalization through governmental provision of services such as electricity and schools. No encroachment on PERU LNG buffer zone has taken place.</p>

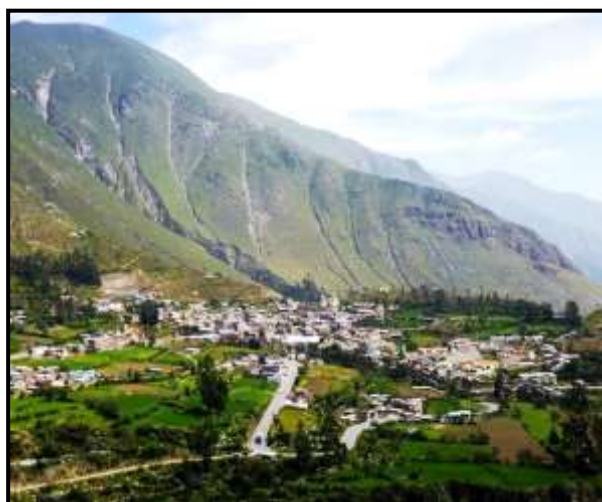
**Picture Nr. 15**

View of the main village (CC of Huyatara).

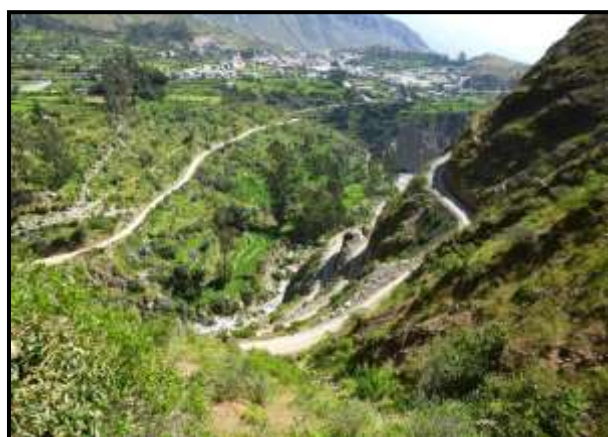
**Picture Nr 16**

Panoramic view of Huaytara Village. In the back the community highlands can be appreciated as well as the gas pipeline ROW affecting 52.5 Ha. Although community leaders expressed concern and reported a slow or no recovery of pastures along the high sections of the ROW, this community also owns lands, pasture and crops in lower altitude, which reduce the impact of the pipeline in the community livelihood. In addition Peru LNG is providing support to various productive initiatives. See Pictures No.17 to 19.

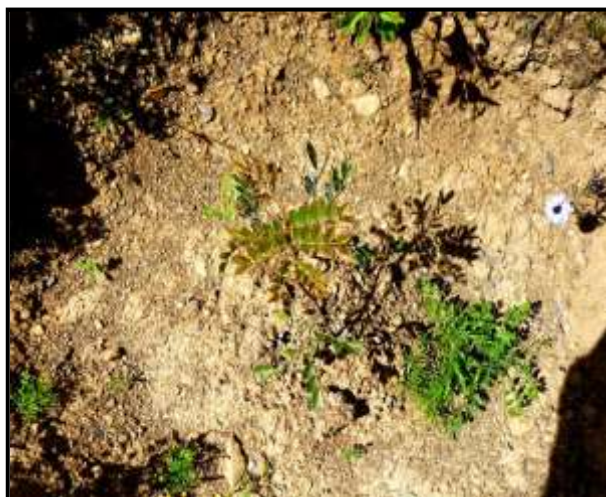
**Picture Nr. 19**

Recently planted Tara Plants. For the Tara cultivation, the Huaytara Peasant community is installing an incipient aspersion irrigation system bringing water from a far-away creek; the irrigation system is also supported by PERU LNG which has provided hosepipes and other implements.

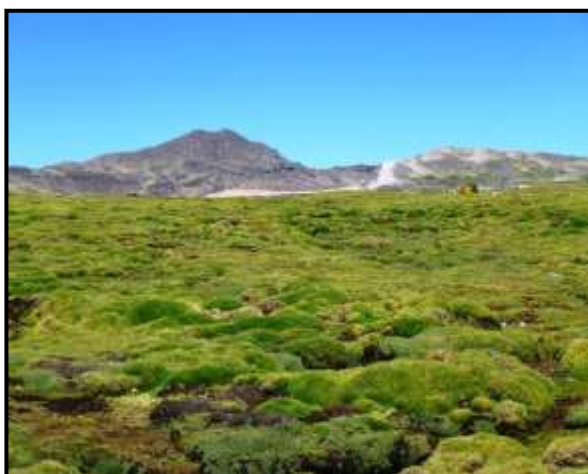
**Picture Nr. 30**

Paccta lands, surrounding the community settlement. In the back, a section of the 21 km long PERU-LNG pipeline Right of Way that crosses Paccta communal lands.

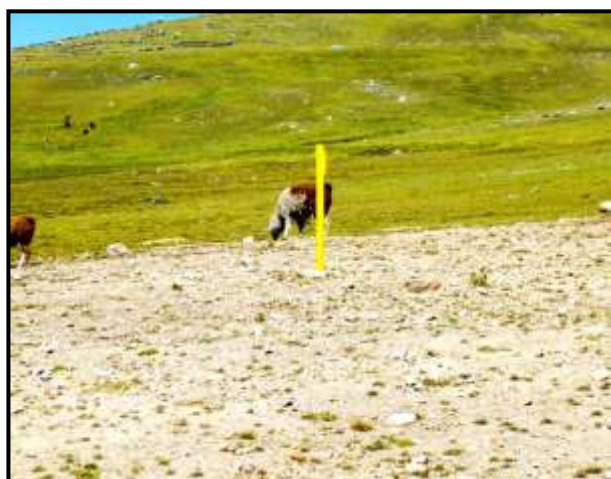
**Picture Nr. 32**

PERU-LNG Right of Way; community members expressed concern due to lack of pastures in the RoW. The area affected in this community is about 52.5 Ha.

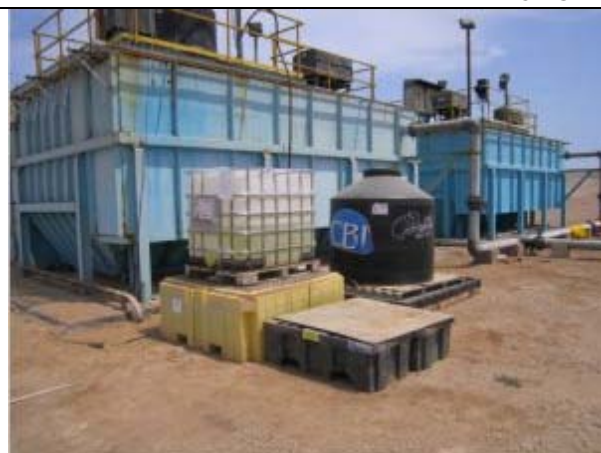
**Picture Nr. 1 -** Wastewater treatment plants (known as "Ex-CBI"). They used activated sludge to get a high rate of waste material degradation, which showed good results during the construction phase.

These treatment plants need to be rehabilitated to treat domestic wastewater.

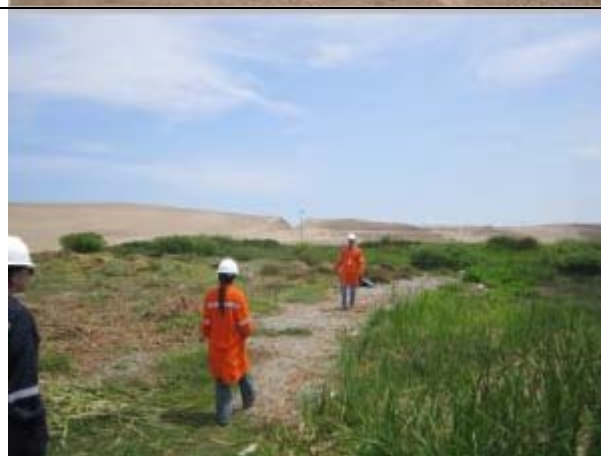
**Picture Nr. 2 -** Wetland for tertiary wastewater treatment. This wetland was built during the construction phase and has been used during the operations phase. Vegetation has been mown to favor nutrients (Nitrogen and Phosphorus) absorption by the plants.

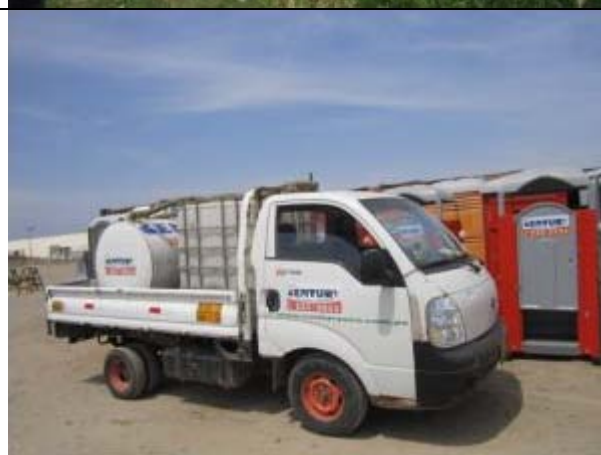
**Picture Nr. 3 -** Portable toilets are used in places where there is no sewage collection system; and where there is maintenance works. Tanker trucks are used to collect sewage from these points.

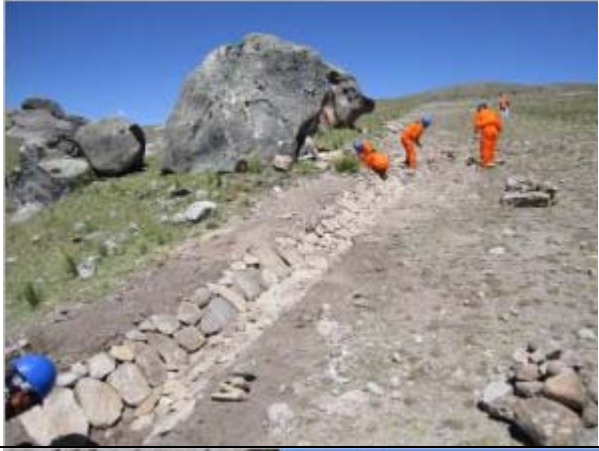
<p>Picture Nr. 4 – Techint personnel (COGA contractor) wearing the appropriate PPE for the work being carried out. (KP 129+100)</p>

During the inspection to the work front in KP 129+100 RoW, COGA personnel and Techint (sub-contractor) had and wear PPE (Personal Protection Equipment), for protection of against hazards that cannot be completely eliminated or controlled, such as falls due to the irregular terrain, eye protection against flying particles resulting from the use of hammers, picks and shovels, fall of heavy rocks or tools, and potential fire exposure. The basic PPE consists in hardhat, fire retardant clothing, safety glasses, hearing protection, steel-toed shoes, and leather or fabric gloves. See Picture N° 4 of the photographic annex. The IESMC had the opportunity to verify that the tools had been inspected in a monthly basis and had their corresponding identification.

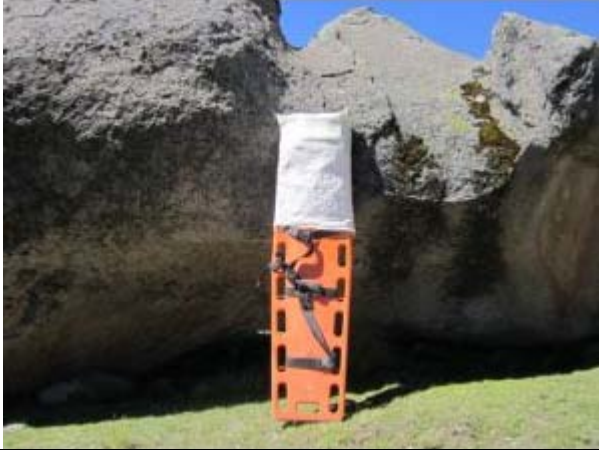
<p>Picture Nr. 5 - Rigid pallet for transportation of an injured person. (KP 129+100)</p>

The work crew included a licensed nurse with enough equipment and medicines to apply first aid for any incident or accident that may occur given the remote conditions where maintenance work is executed. In case of fractures, the nurse has splints for different type of fractures, neck collar, and rigid pallet to transport the injured. Medicine for diarrhea, burns, and for some common illnesses, such as respiratory diseases, is included. The nurse also has available a polyvalent snake serum. For medicine requiring medical prescription, the nurse can consult a physician over the phone. See Pictures N° 5 and 6 of the photographic annex.

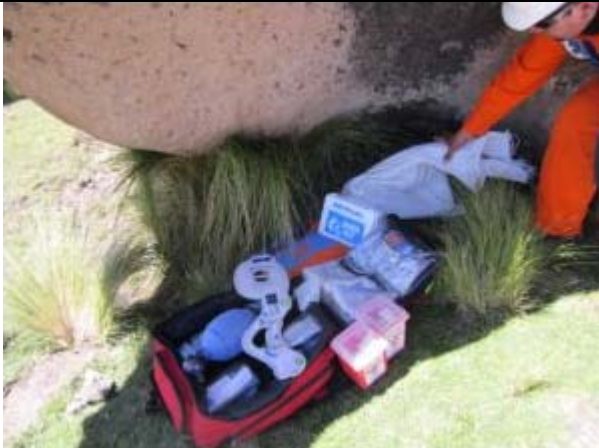
<p>Picture Nr. 6 - First aid materials and medicines of a licensed nurse. (KP 129+100)</p>

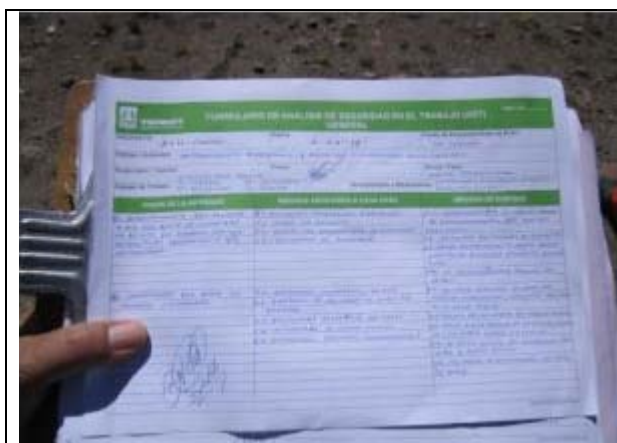
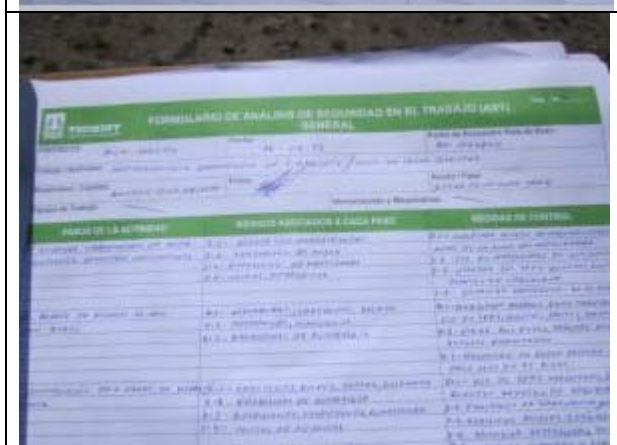
Pictures Nr. 7, 8, and 9 - Job Safety Analysis (JSA) are used to describe work procedures in order to avoid unexpected unsafe actions. The document describes potential risks associated with a task, as well as control measures to avoid accidents. (KP 129+100)

As shown in Pictures 7, 8, and 9 of the photographic annex, work crews had completed the work permit and JSA procedures.

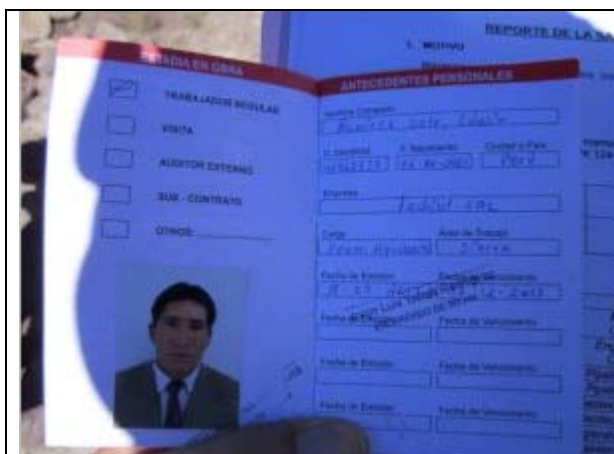
Pictures Nr. 10 and 11 - This is a medical pass, where medical evaluations and vaccines are registered in order to control worker's medical registries. (KP 129+100)

- During the field visit, it was verified that all the personnel had a medical pass. See Pictures 10 and 11 of the photographic annex. Through the medical pass, any inspection can verify that each worker has passed the pre-occupational examination, annual examination, and has the applicable vaccination.
- For Emergency Response preparedness, PLNG performed drills during 2012 for the pipeline. For 2013, PLNG has scheduled drills for car accidents, earthquake, and sabotage to facilities. The location and scenario selected for these drills consider the typical contingencies that may occur during the pipeline maintenance activities.

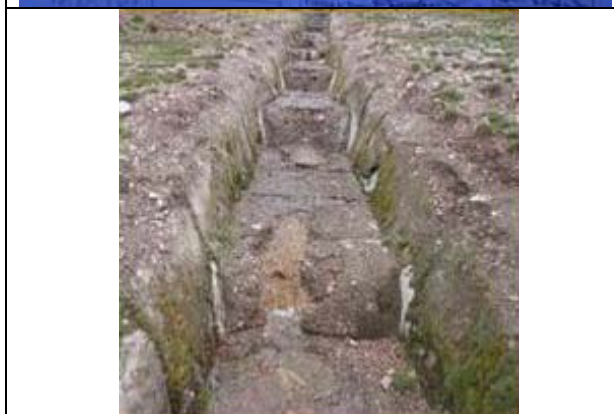
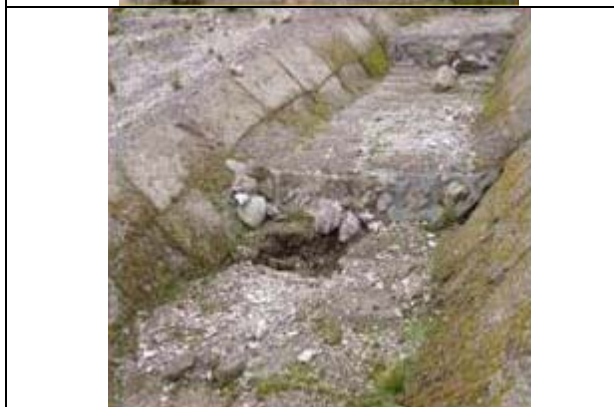
Pictures Nr. 12, 13, and 14 - Examples of impact to artworks to control erosion caused by rain and detected with monitoring programs in order to withstand future rains. (KP 124-134+500)
