# **PERU LNG**

**Independent Environmental and Social Monitoring – IESM  
April 03-04 / 2008 Monitoring Mission**

**LNG Plant and Marine Facilities Final Report**

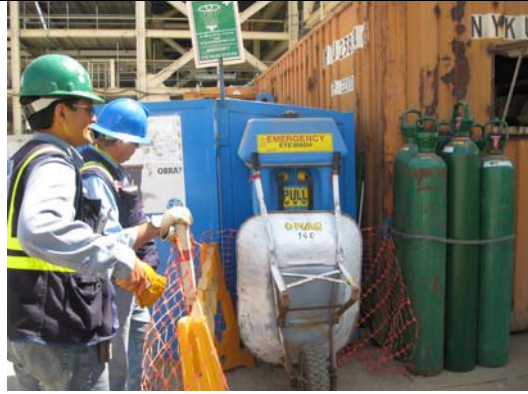
**Location:** Construction front at LNG Plant process area.

- Corrective action is required for eye washing devices. Both eye washing devices found in the area were found with water level below minimum level, and one of them was obstructed by a fence and a trolley.

**Comment:** Eye-washing equipment with small quantity of water and with access obstructed by wheelbarrow and fence. There was another eye-washing equipment nearby with smaller quantity of water.

02.09	Request the Marine EPC Contractor to improve inspection and signaling procedures in order to always maintain eye washing devices full of water.	Health and Safety	Risk for workers' security and health	Inspection and signaling improved. Continuous monitoring.	Corrective action considered satisfactory. This recommendation to be removed from the Tracking Table in next IESM Report.

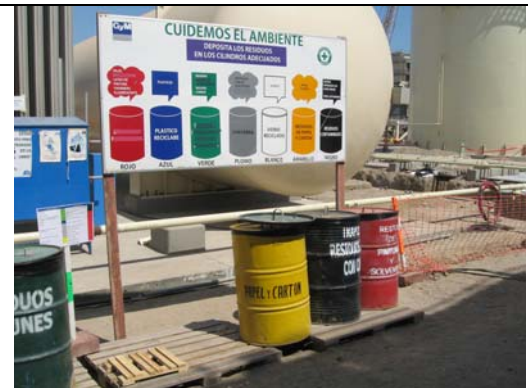
**Location:** Construction front at LNG Plant process area.

**Comment:** Information signage and waste containers painted in different colors, according to types of residues. Waste separation was compliant with established norms.

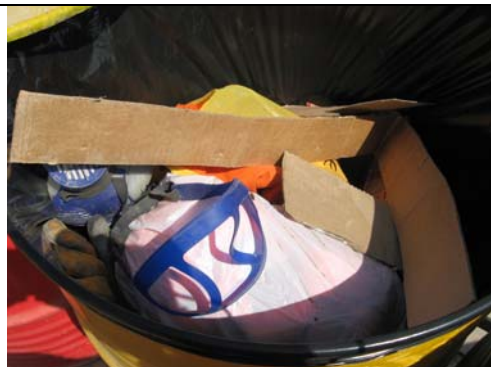
**Location:** Graña y Montero Camp at Melchorita Plant

**Comment:** Containers do not follow CB&I's color standard procedure and waste separation performed by workers was not compliant. Corrective measures were undertaken during the Mission.

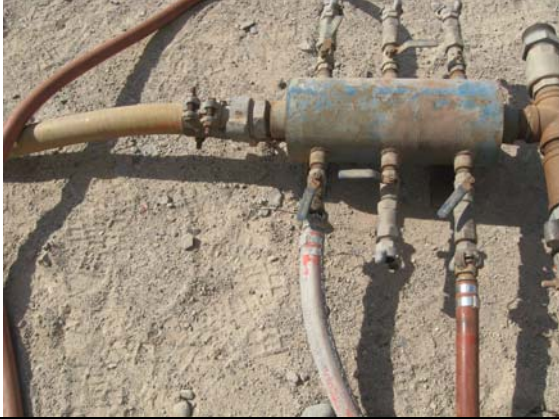
**Location:** Construction front at LNG Plant.

- Though compressed air hoses and connections were found to be in good condition, some hoses lacked high flow shut-off valves and this should require immediate correction.

**Comment:** Not all hoses were equipped with an excess flow safety valve.

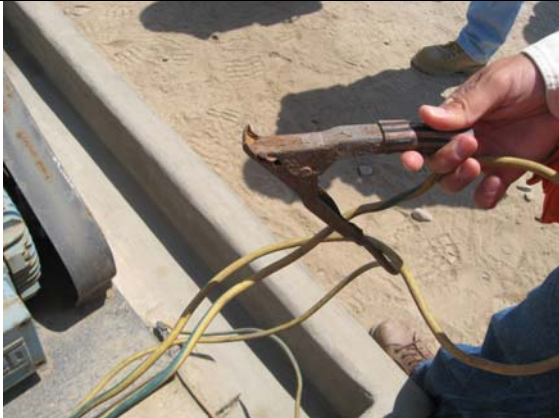
**Location:** Fuel storage and supply area in the San Martin zone.

**Comment:** Anti-static clamp requiring replacement.

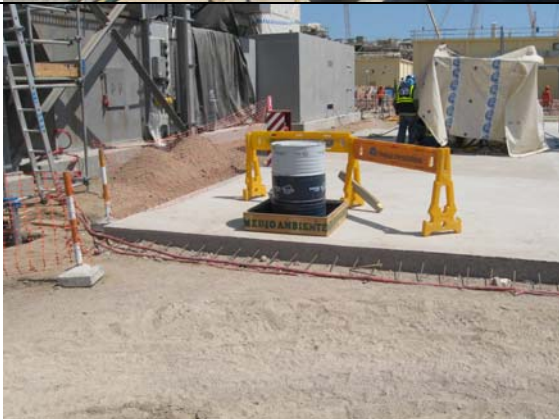
**Location:** Construction front at LNG Plant.

**Comment:** Containment device / tray for fuel or chemical products leaks / spills.

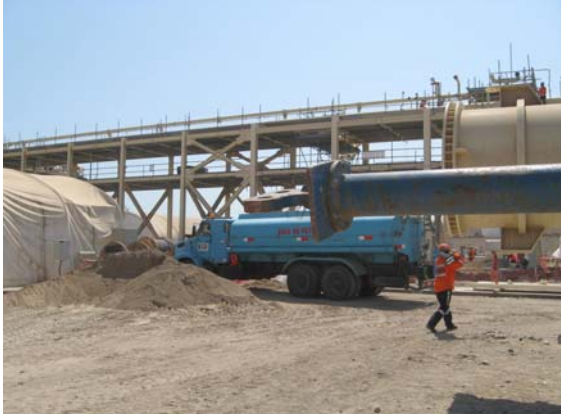
<p><b>Location:</b> Construction front at LNG Plant</p> <hr/> <p><b>Comment:</b> Potential hazard or unsafe condition that might cause head injury. Situation was immediately corrected by installing a warning fence.</p>
--	--
